## Project Profile

# Bioremediation of TPH Contaminated Soil – Allubucket Attachment

Bioremediation treatment of TPH contaminated soil.

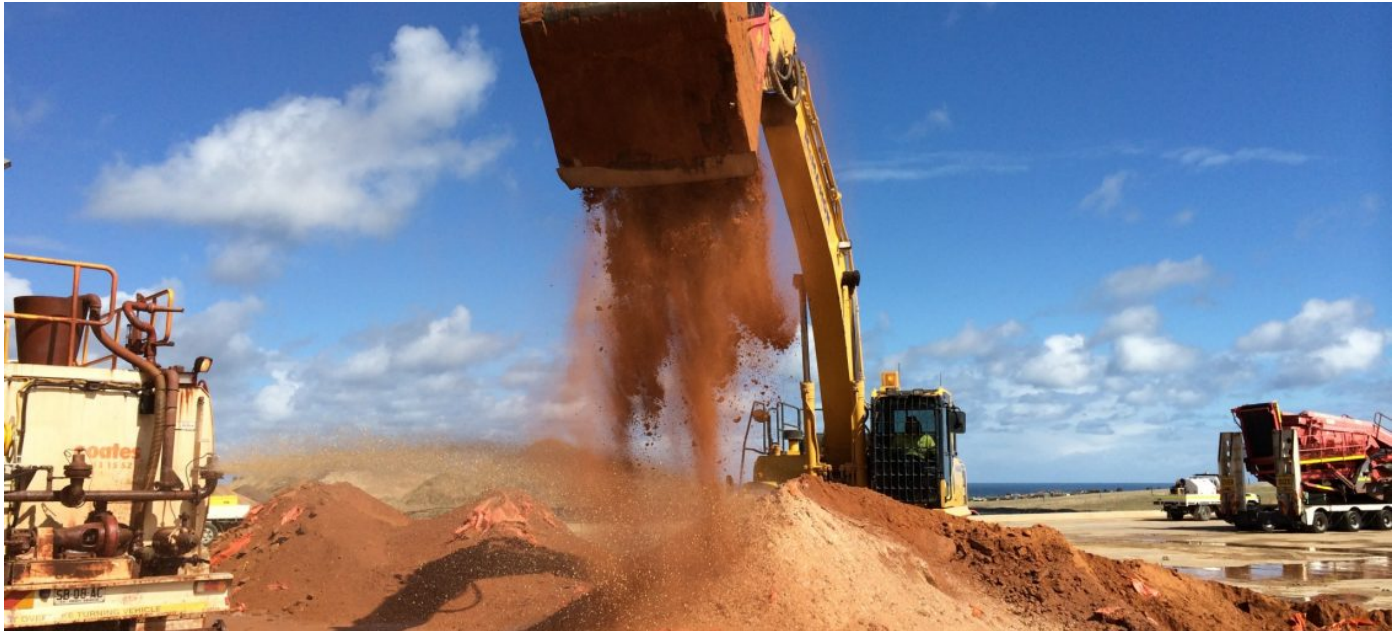
Due to the relatively small volume of contaminated soil, being in the order of hundreds of tonnes, an excavator with an Allubucket attachment was used to both aerate the soil, and break up clumps of high TPH contaminated clumps. This approach was very effective as well as being efficient. As the soil was being discharged from the Allubucket, the liquid nutrient was added, ensuring a homogenous distribution of nutrients throughout the soil profile.

The treated soil was then placed into a windrow and turned to allow effective gas exchange. Concentrations of TPH were monitored over time, as well as process parameters such as pH and moisture. Analytical results showed that concentrations decreased rapidly, and the treatment project overall was a success.
