## Project Profile

# Plant Roof Reinstatement – Bunbury

| <b>Contract</b> | Asbestos Roof Removal & Reinstatement |

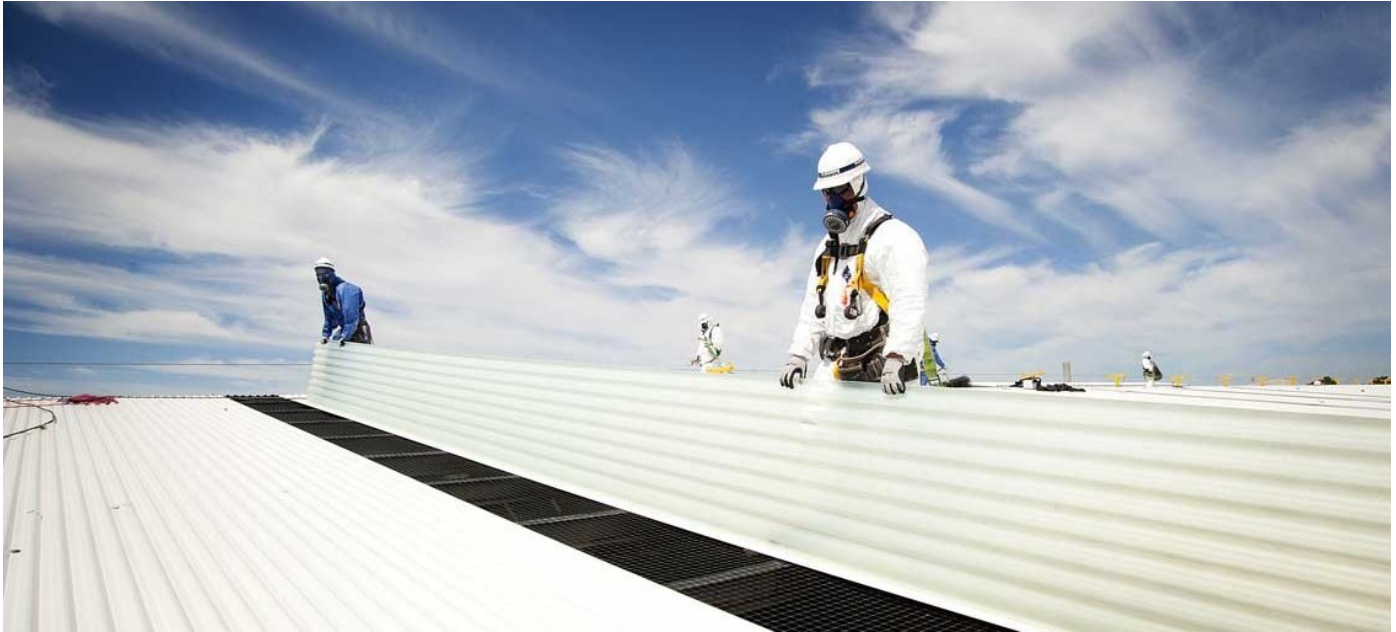
14,000 square metres of asbestos roof removed and a new roof reinstated on a fertiliser facility.

This project involved the roof removal and reinstatement at a large fertiliser facility. Initial works included the displacement of ridge cappings and installation of a tailored static line to ensure maximum safety. The team also laid 75m<sup>2</sup> of 3mm thick mesh onto the existing roof to increase stability. Then, 14 000m<sup>2</sup> of asbestos roofing was systematically removed and disposed of.

The fertiliser stored in the facility was protected using tarps during the roof removal stages. The facility was re-roofed with double-sided ultra spandec, which will slow the rust generated from fertiliser fumes.

The project ran smoothly and on schedule with minimal disruptions. Unpredictable weather meant the team needed to adapt quickly to the challenging conditions, and maintain a high degree of awareness. Additional work included the removal and replacement of rusted purlins.
